# **BRIDGE ALTERNATIVES EVALUATION AND LIFE CYCLE COST COMPARISON**

**BRIDGE STREET**

**MITCHELL RIVER**

**BRIDGE NO. C-07-001 (437)**

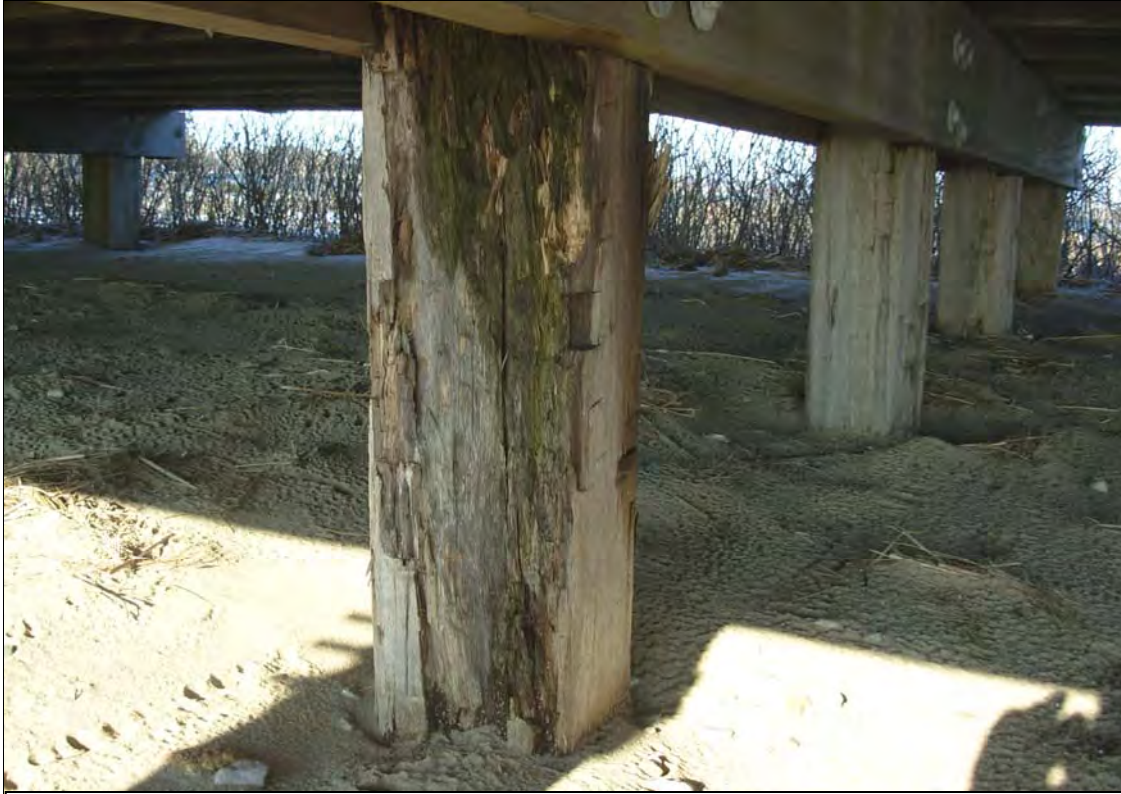
PHOTO - POWDER POINT BRIDGE - TYPICAL PILE CONDITION

The Powder Point Bridge in Duxbury, Massachusetts (a 2,200-foot long, 133-span timber bridge over the Back River at Duxbury Bay) illustrates this concern (see Appendix D.) The bridge was reconstructed in 1987 using piles made from Basralocus. Although Basralocus reportedly is considered highly resistant to decay, the piles exhibited significant decay and deterioration after only 25 years of use. Based on the referenced statements above and the disappointing performance on the Powder Point Bridge, there are reasons for concern with the use of these materials. Ultimately, there is insufficient evidence to support that tropical timber can be used to significantly increase the service life of the piles at this site.
